Arthur Bagirov
 Residential and Commercial Property Inspections
 A Member of the Real Estate Inspection Group, Inc.
 www.inspectiongroup.com

Inspection Date: May 9, 2006	Inspection Time: 9:30 AM	Report Number: 050906
Inspection Address: 1436 Any Street		
Inspection City: Any Town	State: CA	Zip: 95000 Approx. Sq Ft: 2,917
Client's Name: Any Client	Listing Inspection: <input checked="" type="checkbox"/> (Fee due within 90 days)	
Agent's Name: Any Agent	Office: Alain Pinel Realtors	
Phone: (605) 555-1111	E-mail: berter@apr.com	
Amount: \$670.00	Add:	For:
	Billing Fee: 0.00	Total: \$670.00

REAL ESTATE INSPECTION GROUP, INC.

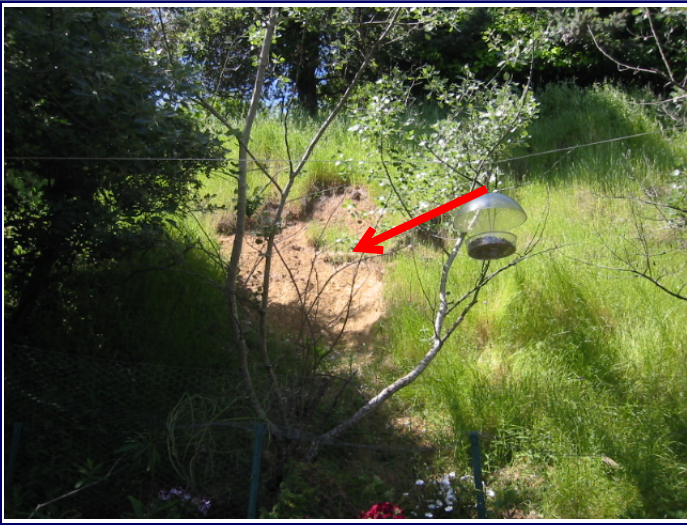
Photo 1

Landslide area.

1. The over steepened slopes behind the building appeared to exceed the maximum slope recommended by current building standards. Additionally, it appears that a minor landslide had developed at the steep slope behind Unit # 36 during recent intense winter storms. CONTINUED ON PAGE 20.

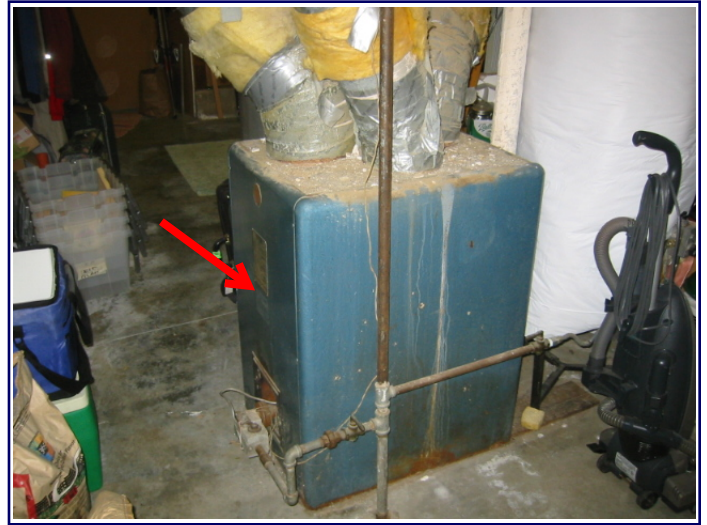
Photo 2

Outdated furnace.

1. It should be recognized that the normal life expectancy of the average furnace is about 20 years, if it is properly maintained. Our inspection only assesses the furnace's current operational condition and can't assure that the furnace will work indefinitely, especially if it has not been properly maintained as recommended by the manufacturer. Occasionally, even if an older furnace operated normally during the inspection, a detailed examination of the unit by a qualified HVAC contractor might reveal potential problems not readily visible during our inspection. If the furnace has been in operation for the term of its expected service life, as suggested by the manufacturer, it will probably malfunction in the future. The inspected units appeared to be more than 40 years old and may be approaching the end of their useful life. Planning for furnaces replacement or repair should be considered a part of the maintenance of the building.

2. The furnaces in the garages were not elevated on a platform as required by current building standards. This installation appeared to predate current standards. However, the furnaces should be installed so that the burners and ignition source are located at least 18" above the garage floor (this will typically be done at the time of the furnace replacement). Additionally, the furnaces should be protected from physical damage by vehicles.

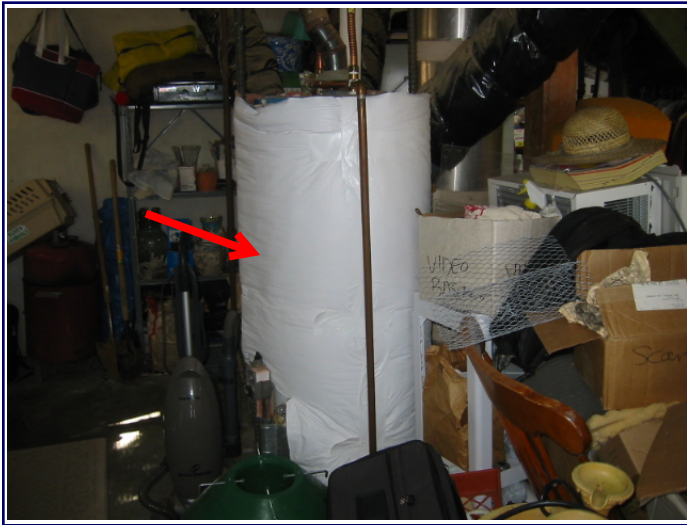
Photo 3

Improperly strapped water heater.

- While provisions for seismic strapping were noted at the water heaters, it was improperly installed to provide adequate support of the unit according to current building standards (there was only one seismic strap and no bracing installed on the water heater in Unit # 36, and improperly positioned straps on the water heater in Unit # 34). As of 1/1/96, sellers are obligated to strap water heaters according to current safety standards (Health & Safety Code sections 19210-19217). The standard calls for two (2) 24 gauge straps, one within 9" of the top, and the second at the bottom third of the tank, a minimum of 4" above the controls. Both straps must be secured with 1/4" X 3" lag bolts. Provisions to support the back of the tank are required to prevent backward or sideways shifting and must be of a non-combustible material. Illustrations and detailed guidelines for proper water heater bracing can be found at:

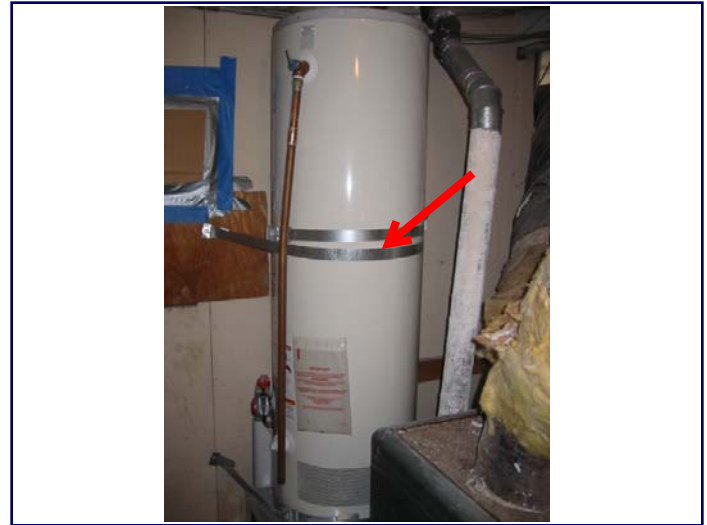
Photo 4

Improperly strapped water heater.

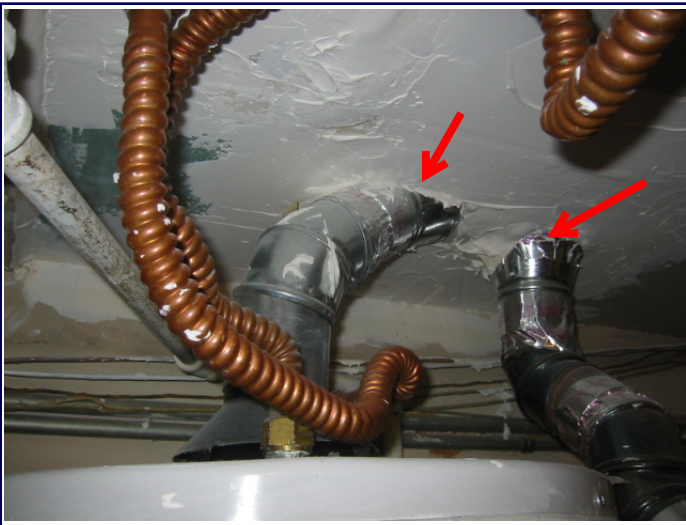
PHOTOS PAGE II

Inadequate clearance to combustable materials and improper flues.

3. The single wall metal furnace flue in Unit # 34 was in contact with the ceiling drywall. I recommend having the drywall cleared and the flue replaced with a double wall vent pipe to allow a minimum of 1" clearance to combustible material.

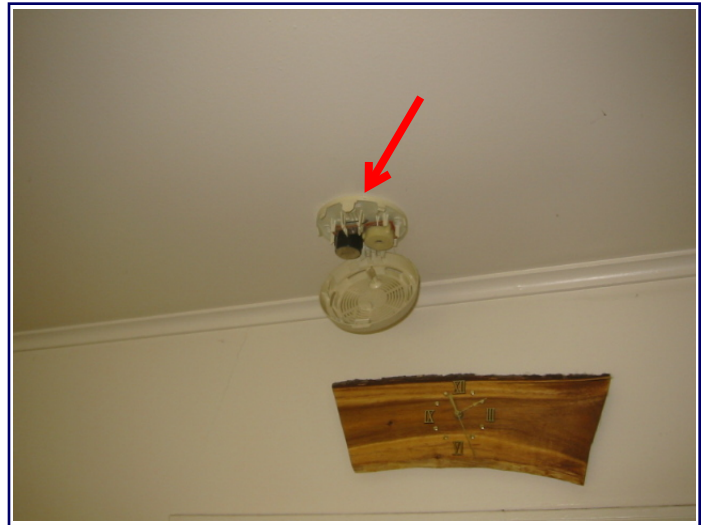
Photo 6

Disabled smoke detector.

5. All smoke detectors in Unit # 34 were disabled. The client is strongly advised to check the installed smoke detectors for safety before occupying the house. For information, at least one detector is required at the entrance to any bedroom sleeping area, more if the building has been remodeled or built since August 1992 (Health & Safety Code 13113.8). Current safety standards require smoke detectors on all levels of the unit and I recommend installing an additional ones on the lower level.

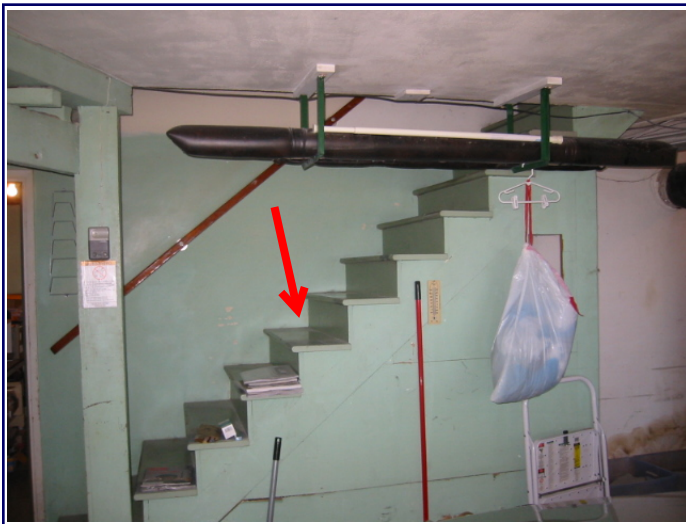
Photo 7

Missing balusters.

2. The garage stairway railings do not meet current standards (the baluster spacing is greater than 4" in Unit # 36, no balusters at Unit # 34 railing, and the stair handrail in Unit # 34 didn't have the returns). I recommend that the railing be modified for safer use.

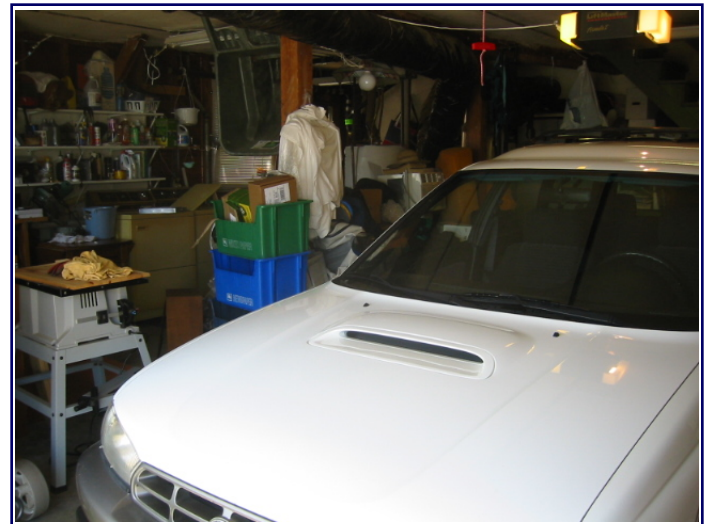
Photo 8

Limited access and visibility in the garage.
